Home Inspection Report

Joe and Amy Anyperson

123 Anyplace St. Anywhere, IN. 46555-5555

12/18/2009

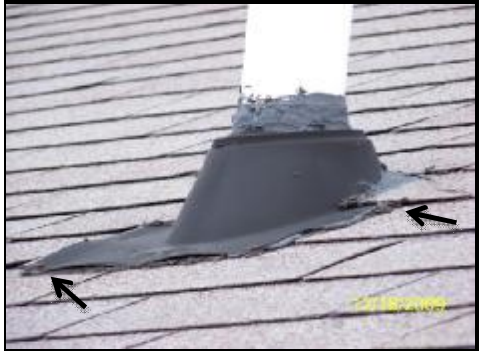
ROOF VENTS AND FLUES:		COMMENTS:	RATING:
<input checked="" type="checkbox"/>	Applicable	Improper installation of boot flashing on plumbing vent observed.	Attention
<input type="checkbox"/>	N/A	(see photo) Flashing was installed over shingles (should be underneath)	
		Exposed nail heads and deteriorated sealant observed around vent.	
		Recommend replacement of boot flashing by licensed roofing contractor.

Improper installation of boot flashing and cracked sealant

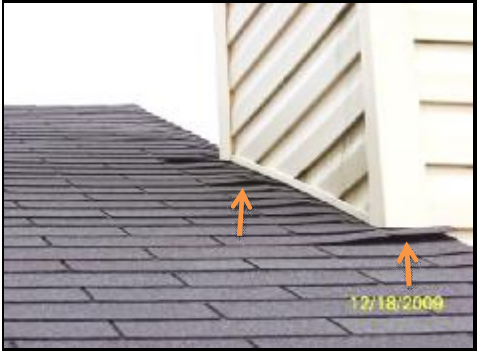
ROOF - SHINGLE:		
<input checked="" type="checkbox"/> Applicable	COMMENTS:	RATING:
<input type="checkbox"/> N/A	Some shingle lift observed at base of chimney. (see photo)	Monitor
<i>Location</i>	Some shingle staining observed in front of home (shingles facing north)	
<input checked="" type="checkbox"/> Primary Roof		
<input type="checkbox"/> Secondary Roof	Recommend monitoring shingles by chimney, repair may be necessary if conditions worsen.	
<input type="checkbox"/> Patio Roof		
<input type="checkbox"/> Heat/Cool Access	Staining is caused by an algae. Recommend cleaning shingles with commercial grade roof cleaner (oxygenated bleach) to remove stains.	
<input type="checkbox"/> Other

Shingle lift

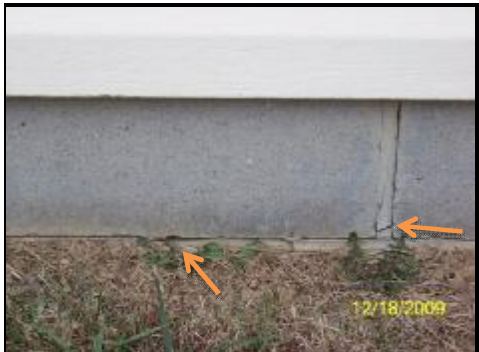
Minor tuckpointing needed

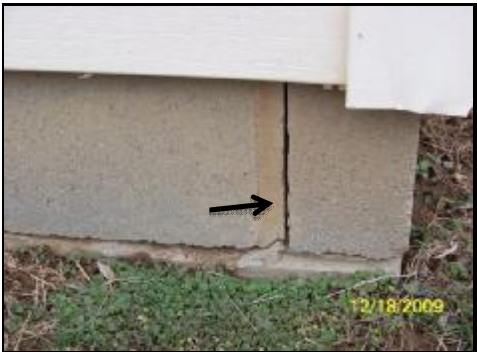
Minor tuckpointing needed II

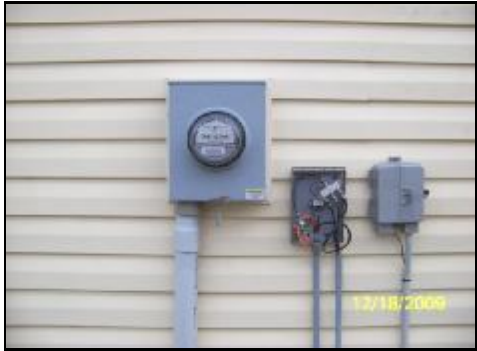
Main electrical service meter (also cable box missing cover)

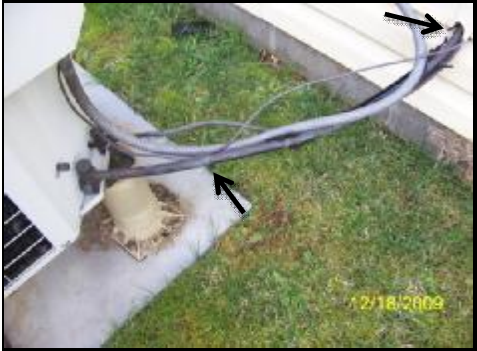
<p>COOLING SYSTEM: The inspector examines only permanently installed cooling systems. Window units are not inspected. If any conditions are listed a qualified HVAC technician should correct them. It is always recommended that a complete servicing and cleaning of the unit be performed prior to next cooling season.</p>		
<input type="checkbox"/> N/A	COMMENTS:	RATING:
<input checked="" type="checkbox"/> Heat Pump	Bryant 3 ton A/C unit. Model# 66ICJ030-A.	Further Review
<input type="checkbox"/> Electric	Approximate age 12 years.	
<input type="checkbox"/> Geothermo		
<input type="checkbox"/> Evaporative		
<input type="checkbox"/> Window	Unit could not be tested due to exterior temperature below 65 degrees. Compressor damage could result if tested below this temperature.	
<input type="checkbox"/> Other		
<i>Location</i>		
<input type="checkbox"/> Exterior	Missing insulation observed on refrigerant line. (see photo)

Missing insulation and HVAC putty

Missing HVAC putty observed where line enters home.	
<i>Size</i>		
<input type="checkbox"/> 3 Ton	Recommend installing insulation over entire refrigerant line and adding HVAC putty where line enters home. (see photo)

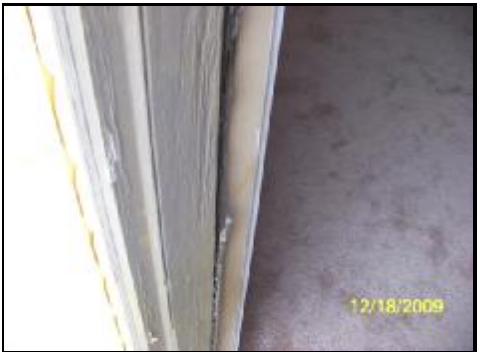
<input checked="" type="checkbox"/>	Applicable	COMMENTS:	RATING:
<input type="checkbox"/>	N/A	Damage observed on rear door weatherstripping. (see photo)	Attention
	<i>TYPE</i>	Exterior trim piece on rear door is loose. (see photo)	
<input type="checkbox"/>	Storm / Screen	Moisture damage observed on bottom of exterior moulding at rear	
<input type="checkbox"/>	Security	door and on side garage door. (see photos)	
<input type="checkbox"/>	Slider/Arcadia		
<input type="checkbox"/>	French Doors	Recommend replacement of rear door weatherstripping, securing bottom	
<input checked="" type="checkbox"/>	Other	trim piece at back door and replacement of affected mouldings.

Damaged weatherstripping at back door

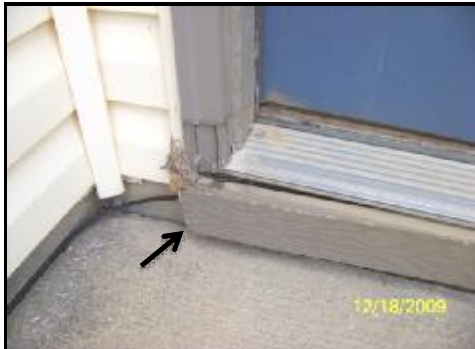
Loose trim piece at rear door

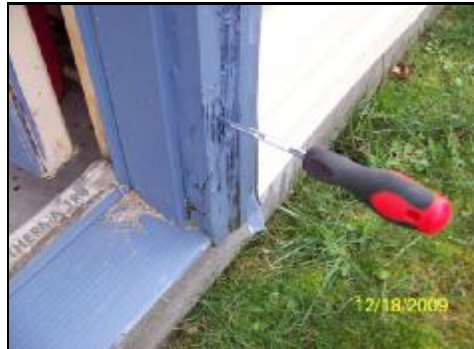
Moisture damaged moulding at side garage door

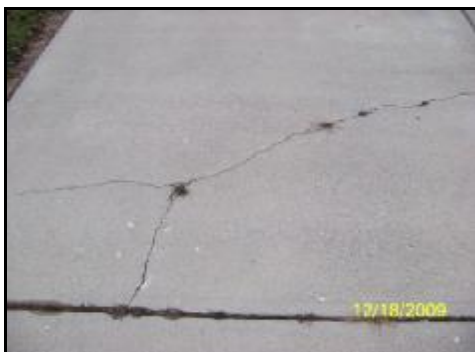
PAVED AREAS:	This category includes steps and/or stoops, sidewalks, walkways, and/or driveways.	
<input checked="" type="checkbox"/> Applicable	COMMENTS:	RATING:
<input type="checkbox"/> N/A	Cracks in excess of 1/8" observed on driveway. (see photo)	Monitor
<input checked="" type="checkbox"/> Driveways	Recommend filling these areas with an epoxy silicone injection to help	
<input checked="" type="checkbox"/> Walkways	prolong life. Recommend monitoring areas for frost heaving during freeze	
<input type="checkbox"/> Steps	thaw cycle.

Crack in driveway

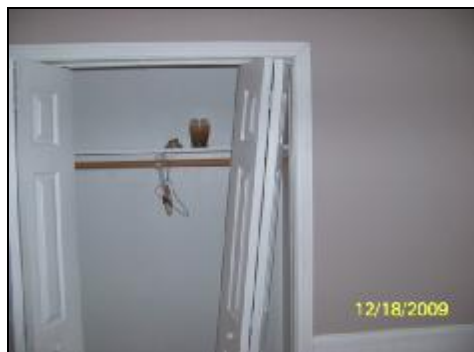
Closet door off track
