Home Inspection Report

1234 Anywhere Rd. Indianapolis, IN. 46268

4/27/2011

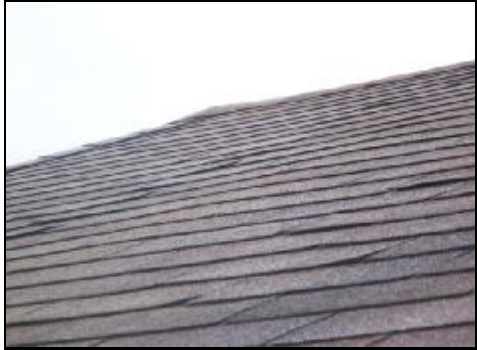
Roof II (shingle lifts)

ROOF - SHINGLE:		
<input checked="" type="checkbox"/> Applicable	COMMENTS:	RATING:
<input type="checkbox"/> N/A	Several missing/torn shingles observed in front and rear of home.	Major Repair
<i>Location</i>	Previous patch repair observed in front of home.	
<input checked="" type="checkbox"/> Primary Roof	Granular loss and pitting observed on shingles.	
<input type="checkbox"/> Secondary Roof	Shingle lift observed in several areas on roof.	
<input type="checkbox"/> Patio Roof	It appears that possible hail damage is present.	
<input type="checkbox"/> Heat/Cool Access	(see photos)	
<input type="checkbox"/> Other	Recommend evaluation of roof and all repairs necessary by a licensed roofing contractor. Obtain all receipts on any work performed.

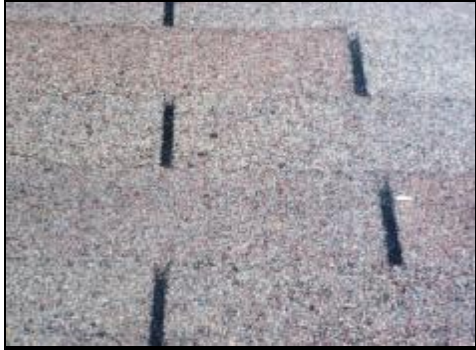
Roof III (granular loss and pitting)

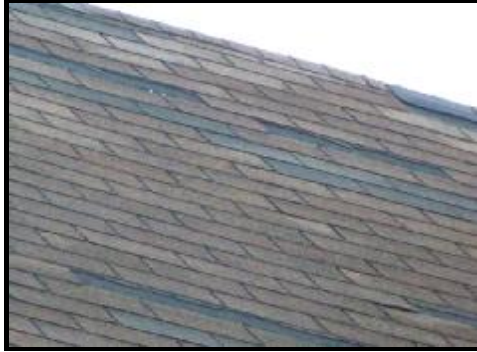
Roof IV (missing/torn shingle tabs, previous patches in front)

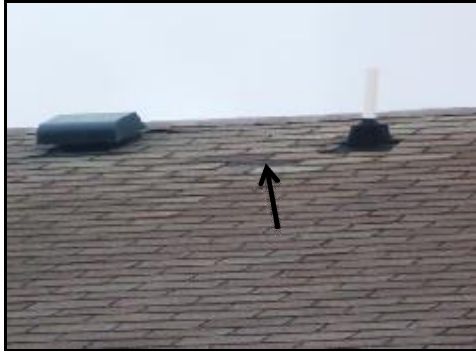
Roof V (missing shingle tab in rear)

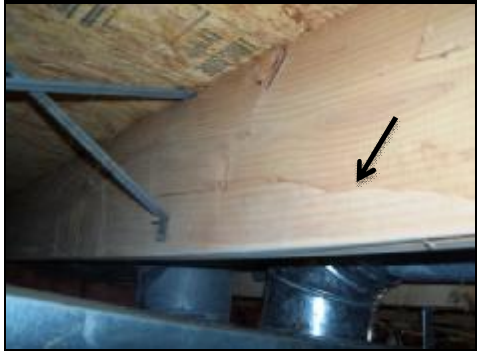
Split floor joist in crawspace (by entrance)

SUB FLOORS/SUPPORT/ JOISTS AND BEAMS:	Inspection of structure may be limited due to interior ceilings, floor covering, walls or insulation.	
<input checked="" type="checkbox"/> Applicable	COMMENTS:	RATING:
<input type="checkbox"/> N/A		Attention
<i>Type</i>	Split floor joist observed near main crawlspace entrance.	
<input checked="" type="checkbox"/> Truss	Split floor joist observed underneath kitchen area.	
<input type="checkbox"/> Framed	Cut out section of floor joist (for plumbing) observed under 1/2 bathroom.	
<input type="checkbox"/> Steel	(see photos)	
<input type="checkbox"/> Masonry	Recommend scabbing affected floor joists by a licensed contractor.	
<input type="checkbox"/> Log	For your protection obtain all receipts for any work performed.	
<input type="checkbox"/> Other	_____

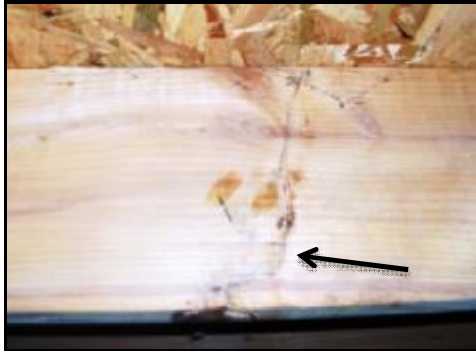
Split floor joist in crawspace (under kitchen area)

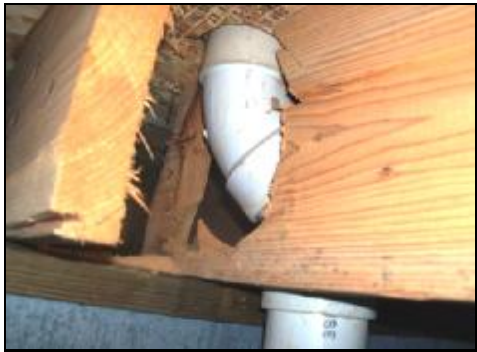
Cut out floor joist (under 1/2 bathroom)

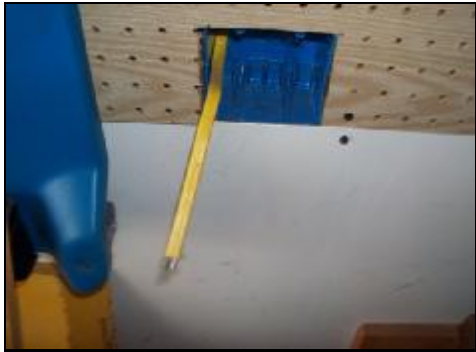
INTERIOR ELECTRICAL:		The inspection covers a representative number of components. If you have any doubt about any electrical discrepancies noted in report, have it thoroughly inspected by a qualified electrician.	
		COMMENTS:	RATING:
		Tested satisfactory at time of inspection.	Satisfactory
<input checked="" type="checkbox"/>	GFCI	_____	
<input checked="" type="checkbox"/>	Smoke Detectors	_____	
<input type="checkbox"/>	CO Detectors	_____	
<input checked="" type="checkbox"/>	Receptacles	_____	
		Open junction box with abandoned wiring observed in garage. (see photo)	Attention

Open junction box in garage

Recommend removal of wiring and installing proper cover on junction box if it is not being used.

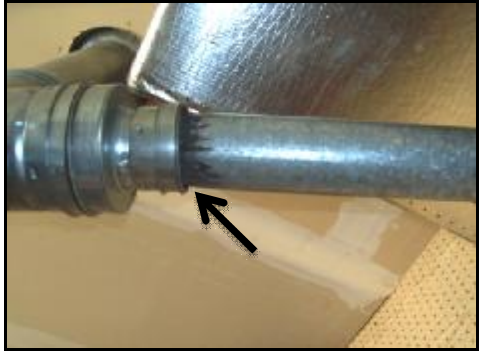
Loose water heater flue pipe connection

WATER HEATER:		The hot water supply system is inspected where visible. Interior heating elements (if any) are not examined. Due to insurance regulations pilot lights are not lit during inspection.		
<input checked="" type="checkbox"/> Gas/Propane		COMMENTS:		
<input type="checkbox"/> Electric		A.O. Smith gas water heater. Model# FCG50248. Approximate age: 8 years.	RATING: Satisfactory	
<input type="checkbox"/> Oil				
<input type="checkbox"/> Tankless				
<input type="checkbox"/> Other				
<i>Location & Size</i>				Unit was functioning satisfactory at time of inspection.
Garage				Loose water heater flue pipe observed at top connection. (see photo)
50 GAL				Recommend properly securing top of water heater flue pipe.
Size			Safety Issue	
Size				
Size

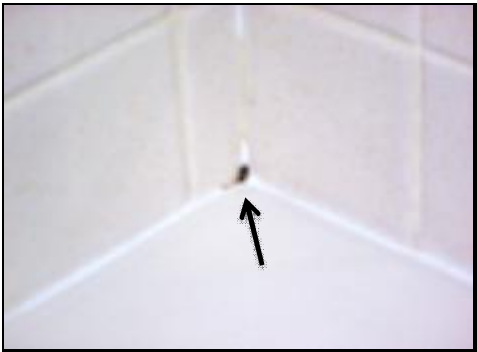
One of several open grout lines in upstairs hall bathtub

TUBS/SHOWERS:	The condition of the bathroom tub and showers are reported in this section. Flow and drainage checked for functionality only.	
<input type="checkbox"/> N/A	COMMENTS:	RATING:
<i>Type</i>	Shower diverter in upstairs hall bathtub not working when tested.	Attention
<input checked="" type="checkbox"/> Shower	Open grout lines observed in tile in upstairs hall bathtub.	
<input type="checkbox"/> Tub	_____	
<input checked="" type="checkbox"/> Shower/Tub Combo	Recommend installing new tub spout w/shower diverter.	
<input checked="" type="checkbox"/> Whirlpool/Garden	Recommend re-grouting and sealing all tile grout in hall bathtub area to prevent moisture intrusion.

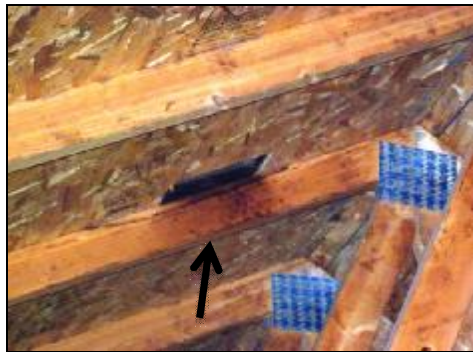
Attic III (moisture stains under cap vent)

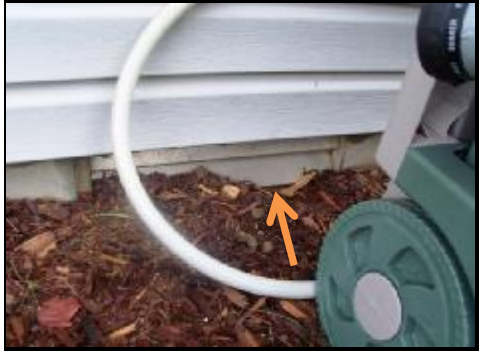
Partially covered crawlspace vent in rear

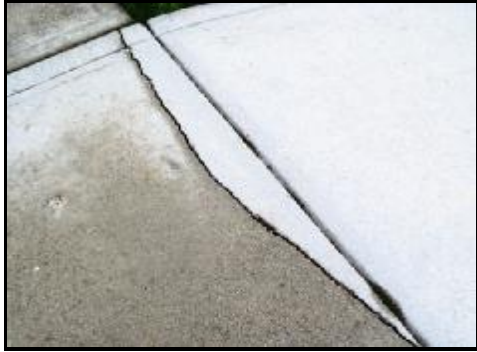
PAVED AREAS:		This category includes steps, sidewalks, walkways, and/or driveways.	
<input checked="" type="checkbox"/>	Applicable	COMMENTS:	RATING:
<input type="checkbox"/>	N/A		Crack observed on front walkway. (see photo) Minor pitting observed on front driveway.
<input checked="" type="checkbox"/>	Driveways		
<input checked="" type="checkbox"/>	Walkways	Recommend filling in crack with a self leveling concrete patch.	
<input checked="" type="checkbox"/>	Steps	Recommend sealing driveway with a silicone based concrete sealer to help prevent premature deterioration.

Crack on walkway

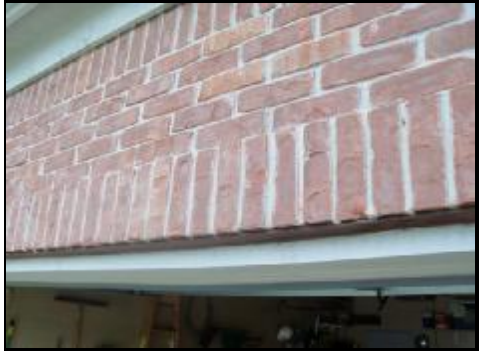
Missing weep holes on brick facing

SIDING:		Siding refers to the visible material forming or covering the exterior walls. Masonry construction can perform structural as well as siding functions.	
<input checked="" type="checkbox"/>	Applicable	COMMENTS:	RATING:
<input type="checkbox"/>	N/A		Missing weep holes observed on brick facing. Open section of siding observed in rear due to improper cut. Several small holes observed on north side due to weed eater.
	SIDING MATERIAL		
<input checked="" type="checkbox"/>	Vinyl	Recommend patching siding using a vinyl siding patch repair kit.	
<input type="checkbox"/>	Wood	Recommend installation of proper weep holes on brick facing every 24-36" above every header (garage and windows) and at grade level.	
<input type="checkbox"/>	Aluminum	This should be done by a licensed mason.	
<input checked="" type="checkbox"/>	Brick		
<input type="checkbox"/>	Stone		
<input type="checkbox"/>	Stucco		
<input type="checkbox"/>	Fiber

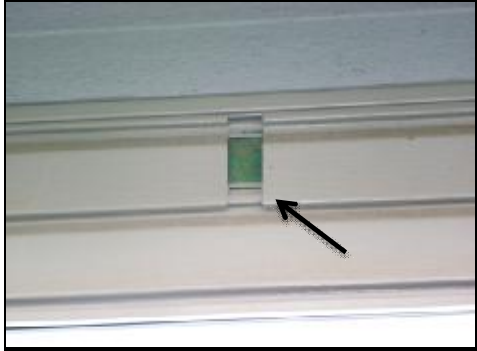
Open gap in siding (in rear)

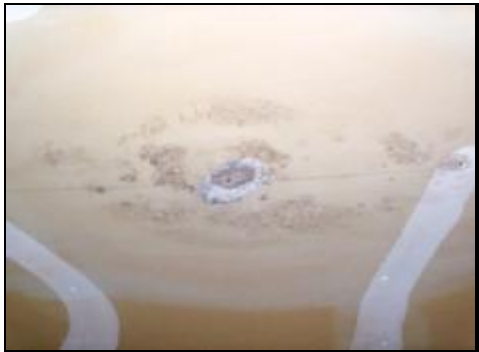
Mold stain on ceiling in 1 car garage

PARKING:		Standard inspections cover attached garages and carports only. Garages are not considered habitable, and conditions are reported accordingly. Detached garages are not normally inspected.	
<input checked="" type="checkbox"/>	Applicable	COMMENTS:	RATING:
<input type="checkbox"/>	N/A		
	<i>TYPE</i>		
<input checked="" type="checkbox"/>	Attached Garage		
<input type="checkbox"/>	Detached Garage		
<input type="checkbox"/>	Carport		
<input checked="" type="checkbox"/>	Door Opener	Mold observed on ceiling in one car garage area. (see photo)	Attention
<input checked="" type="checkbox"/>	Reversing Sensors		
		Recommend removal of drywall section, inspection of area above drywall to ensure no other damage is present and replace with new drywall.	
		**see roofing section for additional information on section above this area.

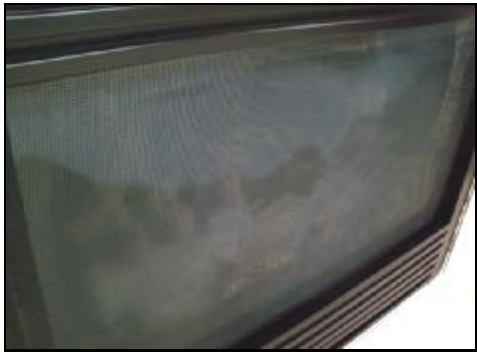
Fogged glass on direct vent gas fireplace

FIREPLACE / CHIMNEY:		We recommend that all chimneys / flues be thoroughly inspected and cleaned by a qualified Chimney sweep before use. Due to insurance regulations fireplaces or woodstoves are not ignited during the inspection.	
<input checked="" type="checkbox"/> Applicable	COMMENTS:	RATING:	
<input type="checkbox"/> N/A	Direct vent gas fireplace.	Further Review	
	Front window fogged during testing. This is typically an indication of an obstruction in either the inlet or outlet combustion air ducts. (see photo)		
	Recommend evaluation of fireplace and any repairs necessary by a qualified contractor. Obtain receipts on any work done.
